Proposed Comprehensive Development at Wo Shang Wai, Yuen Long

Monthly EM&A Report for October 2011 (Rev. B)

November 2011
Report No.: 266567/28/B

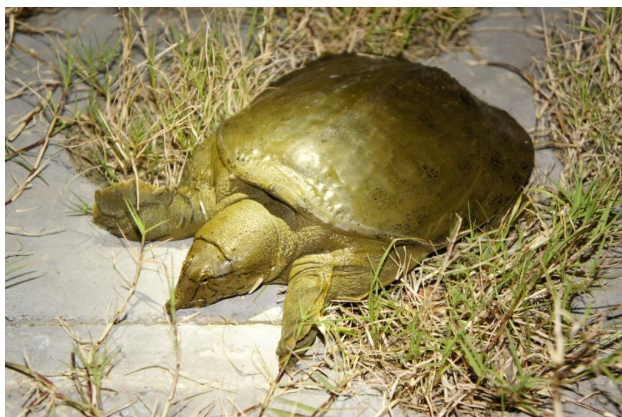
Photo 1: Chinese Soft-shelled Turtle photographed in the WRA on 24th October 2011

Two day time herpetofauna surveys were conducted in the period. One Chinese Soft-shelled Turtle *Pelodiscus sinensis* was recorded within the WRA outside of routine herpetofauna surveys. This species is listed as vulnerable in both the IUCN red list and the China Red Data Book and as of “Global Concern” in Fellowes et al. (2002). This is the first record for the site of this species. In addition, a Checkered Keelback *Xenochrophis piscator* was also recorded outside of routine surveys.

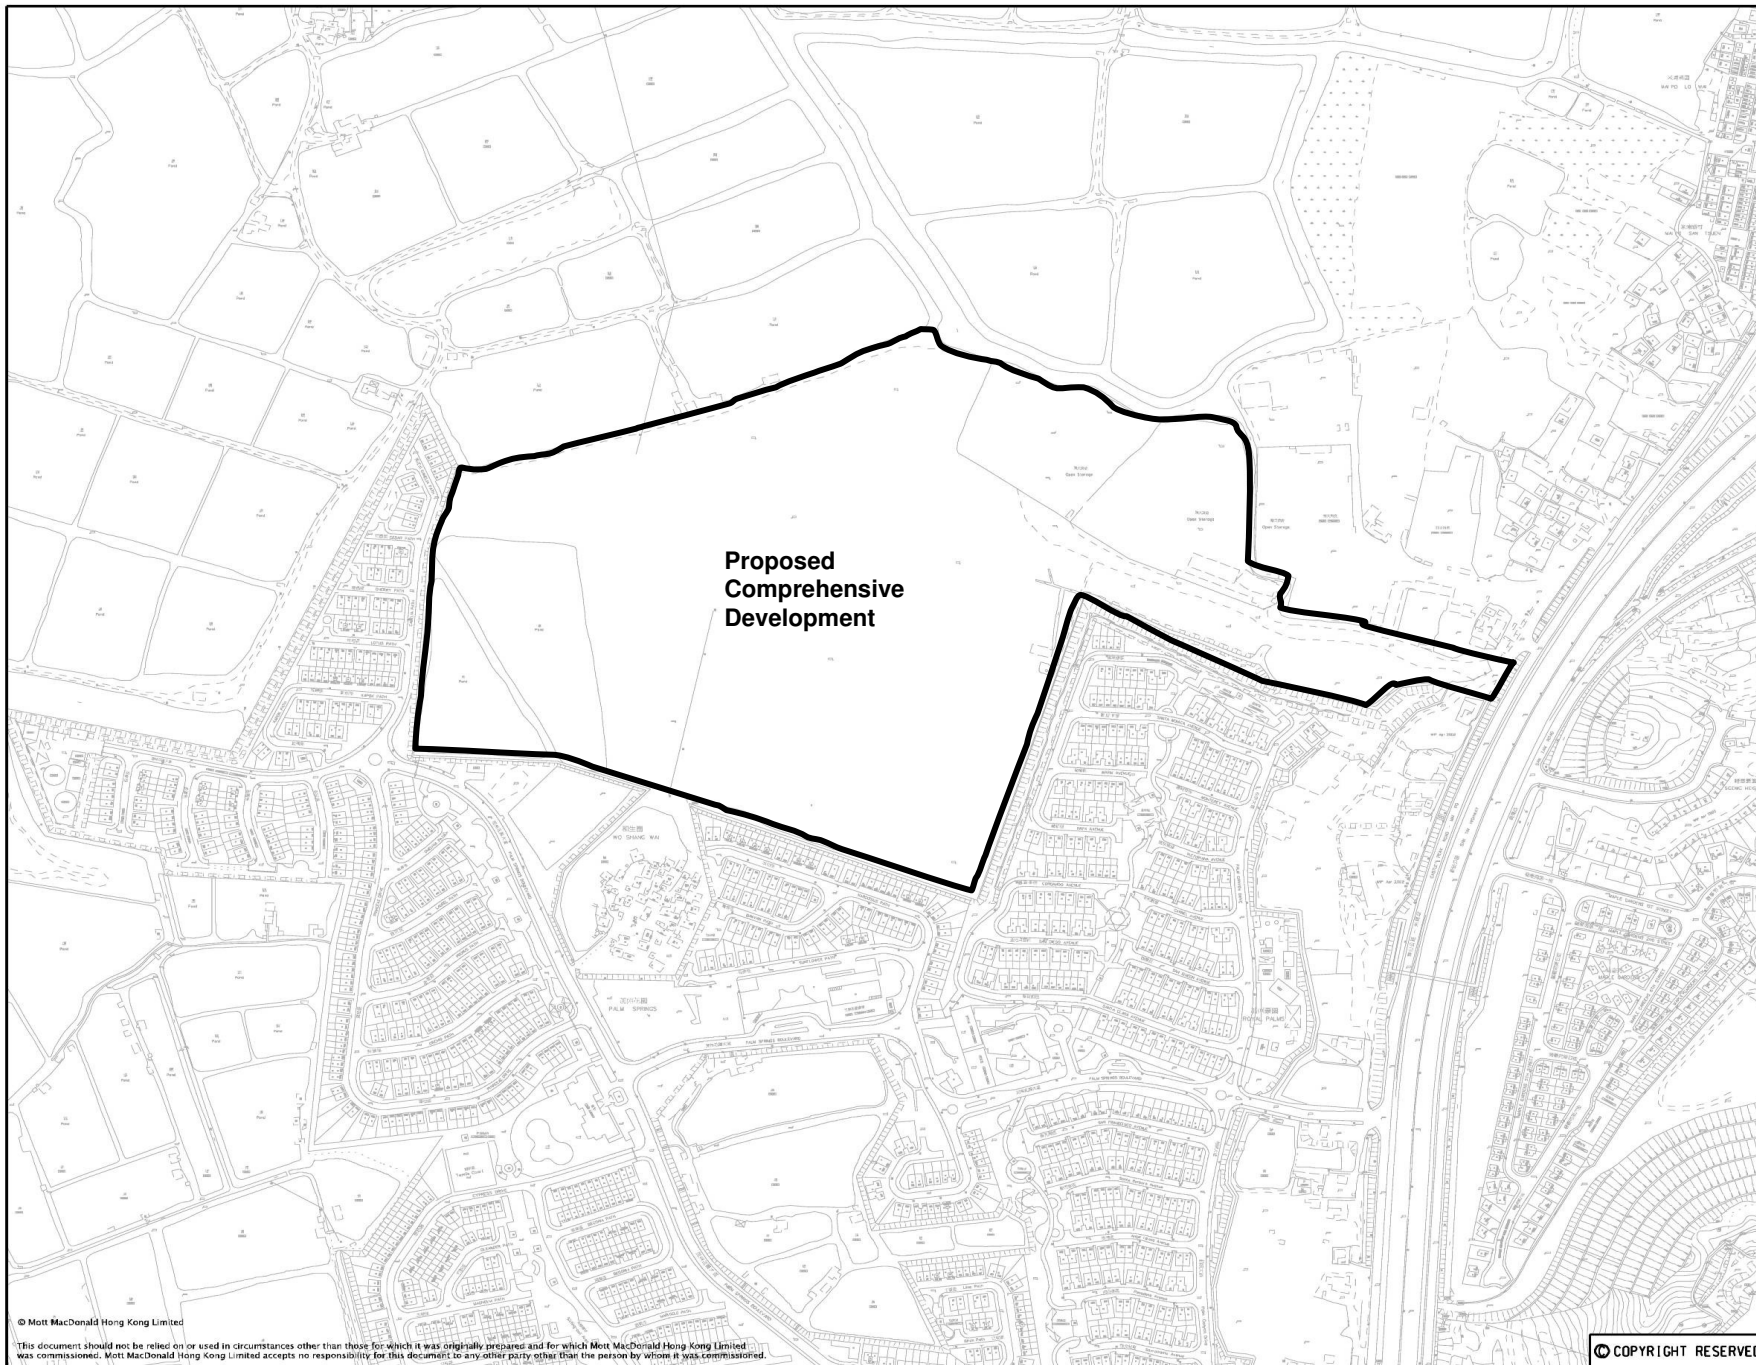
Figure 1.1

The Construction Works Programme of the Project is provided in [Appendix B](#). The general layout plan of the Project site is shown in [Figure 1.1](#).

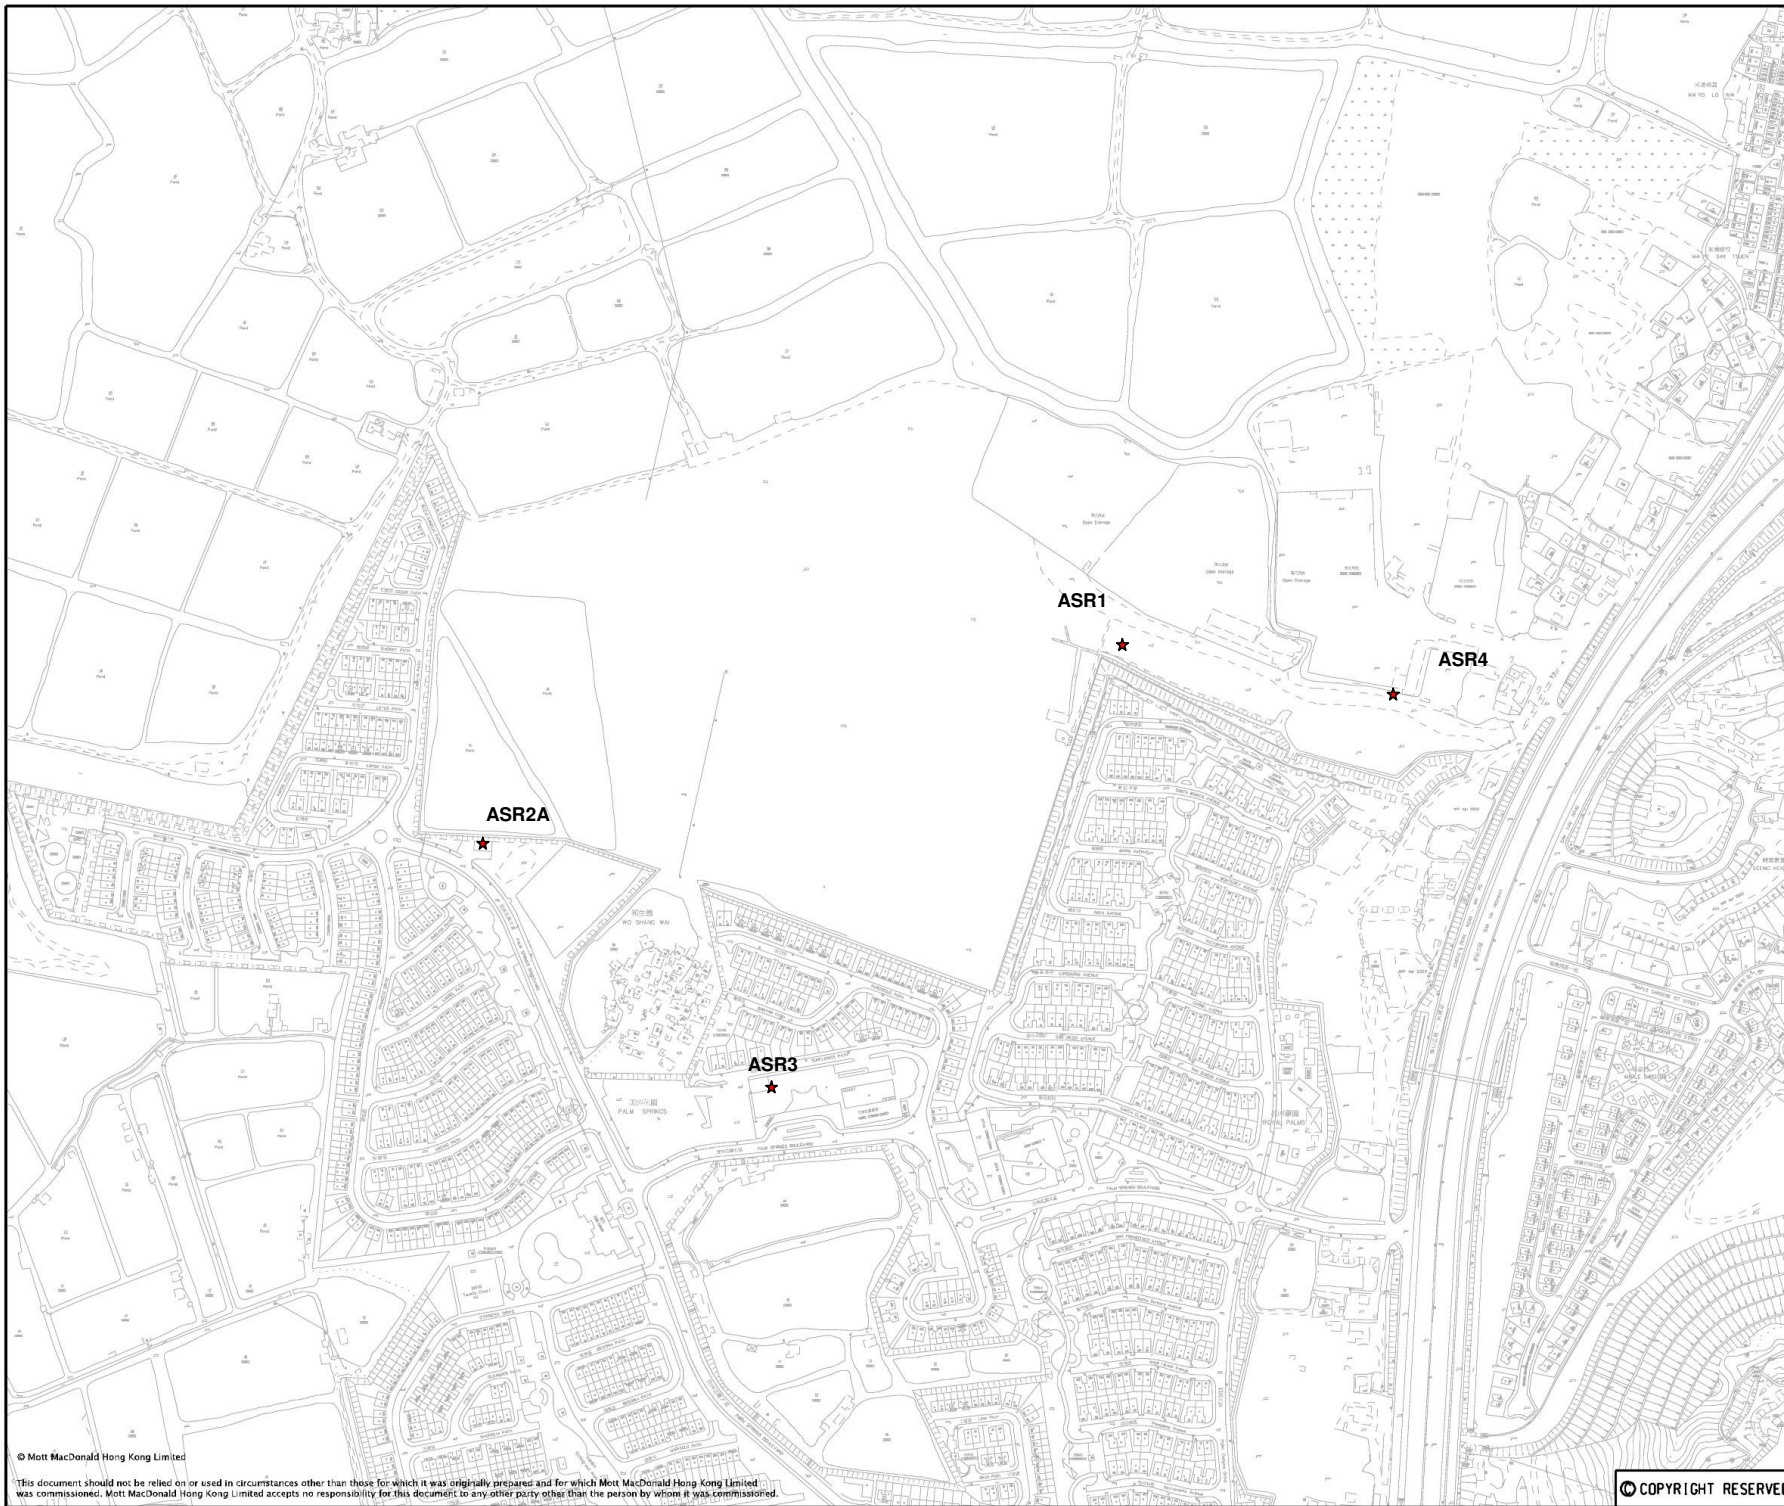
Figure 2.1

The 4 air quality monitoring stations were established in the EM&A manual and were slightly adjusted during the baseline monitoring phase. Locations of the agreed air quality monitoring stations are listed in **Table 2.2** and as shown in [Figure 2.1](#).
